AFDAU-T1

Service Information Letter

SUBJECT: UPDATE TO WIRING DIAGRAM FOR ONBOARD SYSTEMS C40 INDICATOR INTERFACE

Effectivity: All AFDAU-T1 installations interfaced with an Onboard Systems C40 indicator

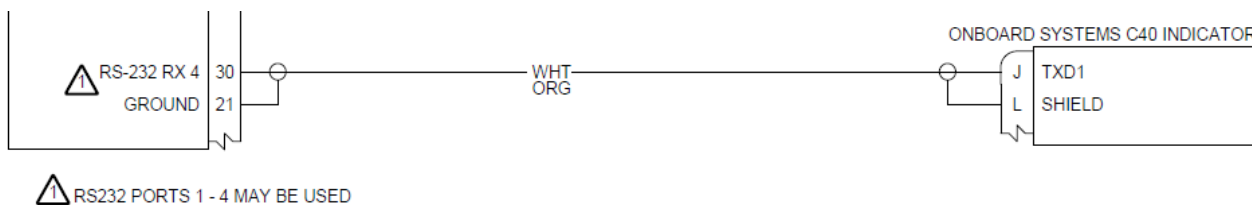
Rev 8 Diagram:

AMS would like to advise a change to Wiring Diagram 5B in the installation manual (P/N: AMS-IM-1-001 Revision 9) which has been updated with a correction. The correction relates to how the ground wire for the C40 to AFDAU-T1 serial bus is connected. Originally it was shown to be connected to Pin L of the C40 Indicator. Advice obtained from Onboard Systems has been that this would be ineffective and may cause a communication issue between the AFDAU-T1 and C40 indicator. The wiring diagram has been changed to a more appropriate configuration, as show below.

AMS recommends no further action is required unless the customer is experiencing communication issues between the AFDAU-T1 and C40 Indicator. Once corrective action has been taken, a final functional check of the system is recommended.
